Jacki Brown
Arboricultural Consultant
New Leaf Arboriculture Pty Ltd

14 April 2021

Supplementary Arboricultural Assessment - 1 tree at 7 Harrabrook Ave, Five Dock

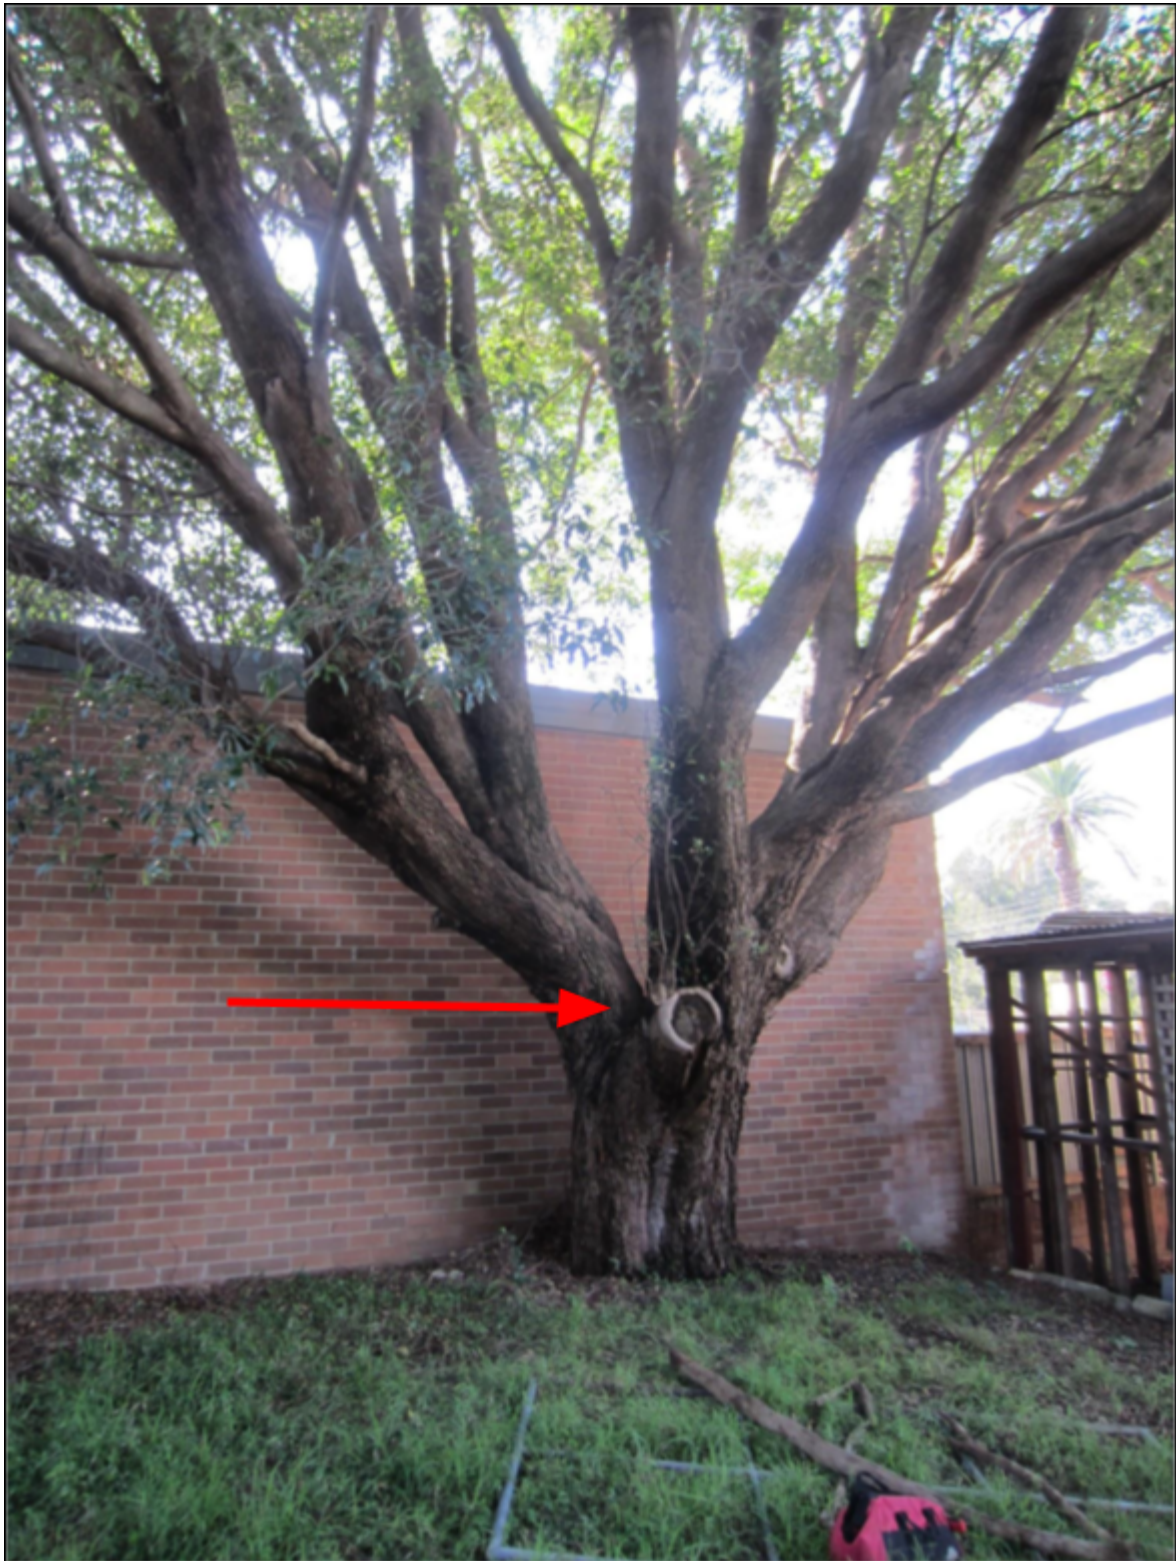
2. The tree was found to be in good to average health, with somewhat sparse foliage at the apex, for the species (*Syzygium paniculatum*, Magenta Cherry). The tree is a native species and provides amenity and environmental benefits in the locality. The structural condition of the tree was assessed to be average to poor, mainly due to an active split (partial failure) at one of the main unions at approximately 1.7m above ground level. The crack extends to 0.7m above ground as an open fracture, but it appears that the weakness continues to ground level. The size of parts (upright branches) affected by the defect are 500mm and 700mm diameters, and these branches extend to the full height of the tree. The base of the tree is in contact with the brick wall of the neighbouring building, and there is a diagonal crack across the wall from the point of contact with the tree up to the corner of the building where 1cm upward displacement between bricks has occurred.

3. If total failure of this tree defect were to occur, about 50% of the tree's crown would be lost, and the remaining crown would be open to different wind loading and biased to the south over the yard of the property, and potentially increasing the "lever arm" action against the brick wall which the base of the tree is in contact with.

4. A full Tree Risk Assessment has not been carried out due to timing, however utilising the principles of Tree Risk Assessment (based on the ISA TRAQ method), the likelihood of failure of this part is estimated to be either probable (over a one year period) or imminent; the likelihood of impacting the neighbouring building is high, and the likelihood of impacting people would be low to medium, assuming a low occupancy rate at the rear of the yard (with severe consequences for impacts to people, and minor consequences for impact to the building). This results in an estimated Risk Rating of Moderate risk to the building, and Moderate to High risk to people.

Photo A: Indicating the location of the failed main union. Tree viewed from south.

5. Mitigation options for this tree could include crown reduction, and/or cable bracing or bolting the affected parts. However, these possible actions should be weighed against the tree's location in contact with and impacting the structure of the neighbouring building which also limit the tree's useful life expectancy. Removal of the tree is a potential mitigation option, which may be required.

- A tree permit or development approval should be sought to remove the tree due to its structural condition, and limited useful life expectancy in the current context.
- If the tree is found to be ecologically significant, the tree should be used for propagating new specimens to be planted in the local area and/or on site. Otherwise, suitable native replacement tree planting should be carried out on site to offset the loss of this tree.

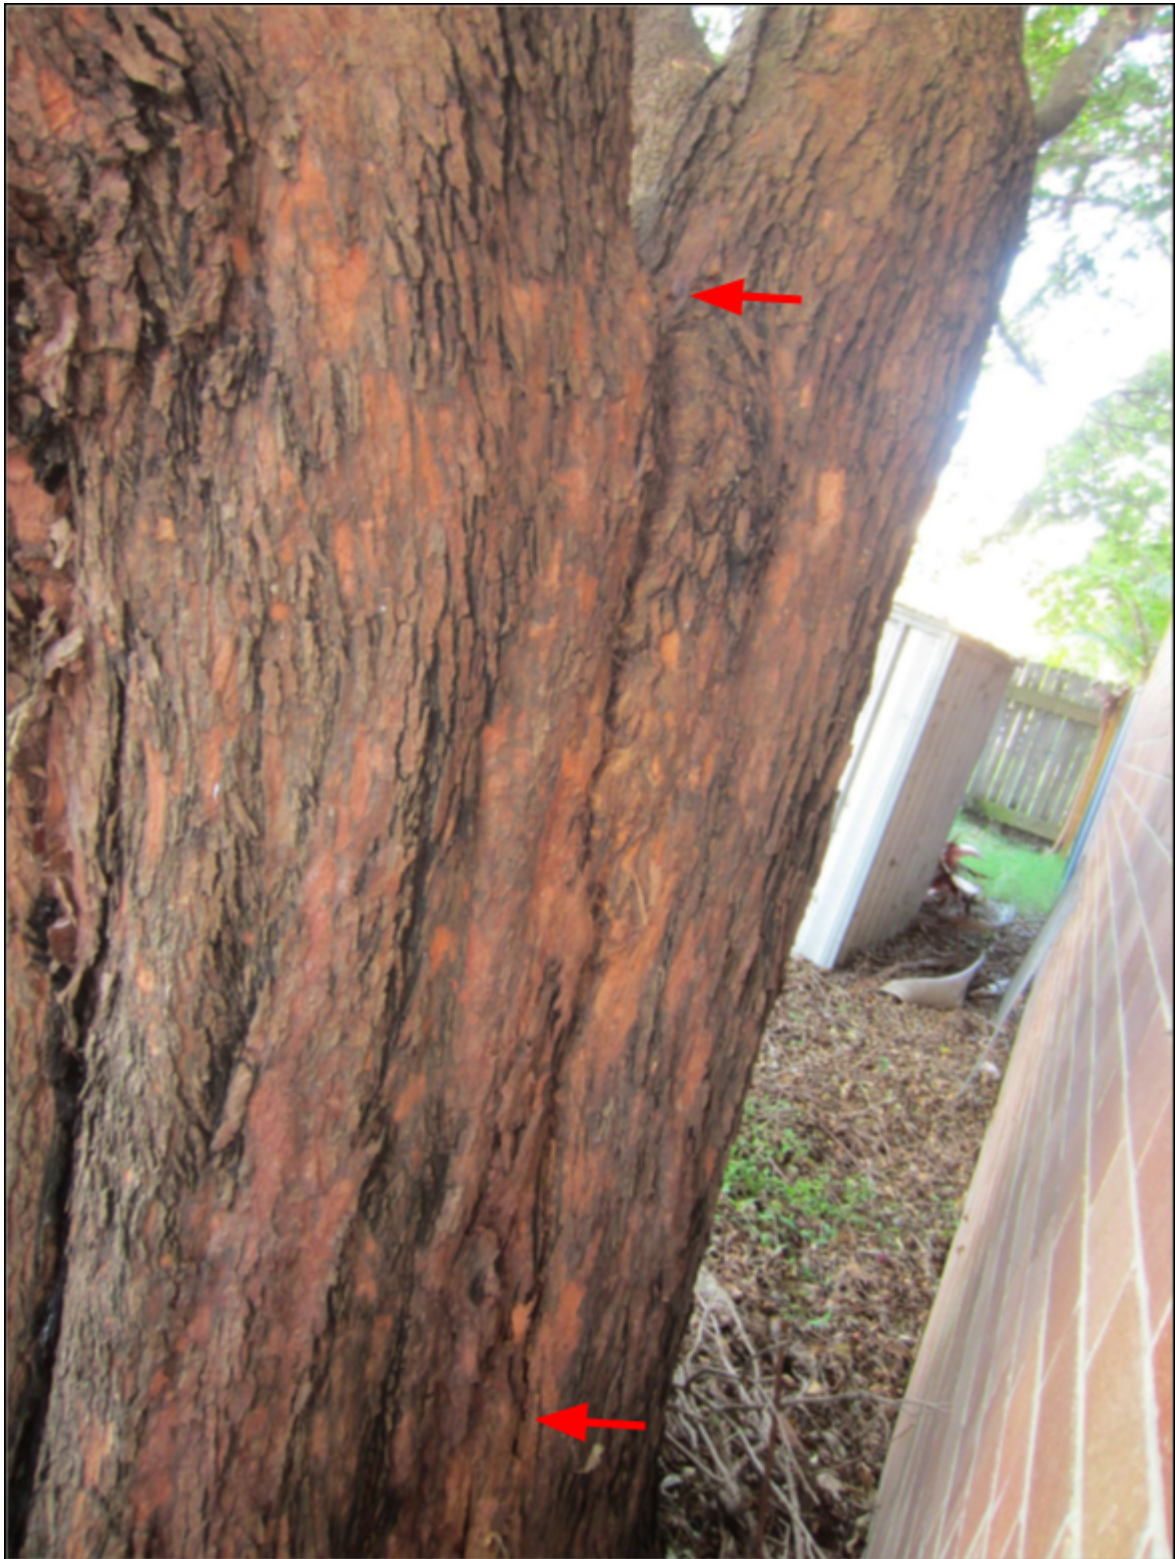
Photo B: Indicating the length of the crack so far. Tree viewed from east.

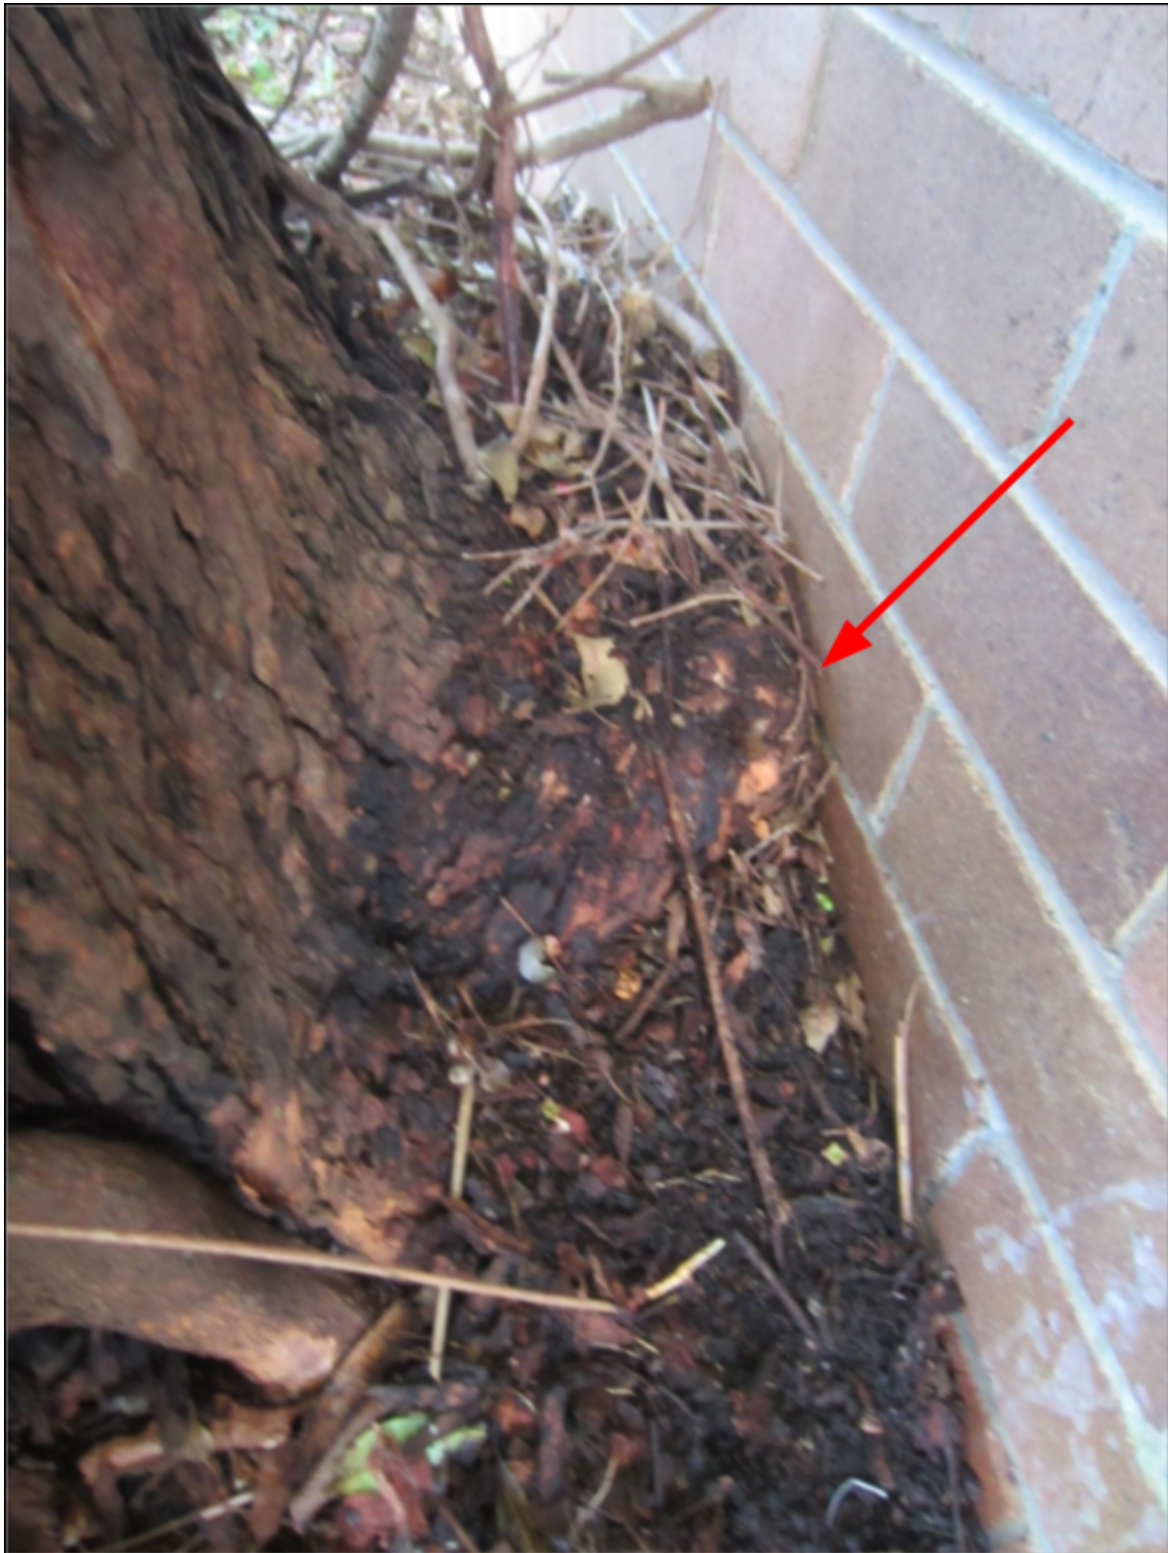
Photo C: Indicating the root buttress in contact with the brick wall. Tree viewed from east.

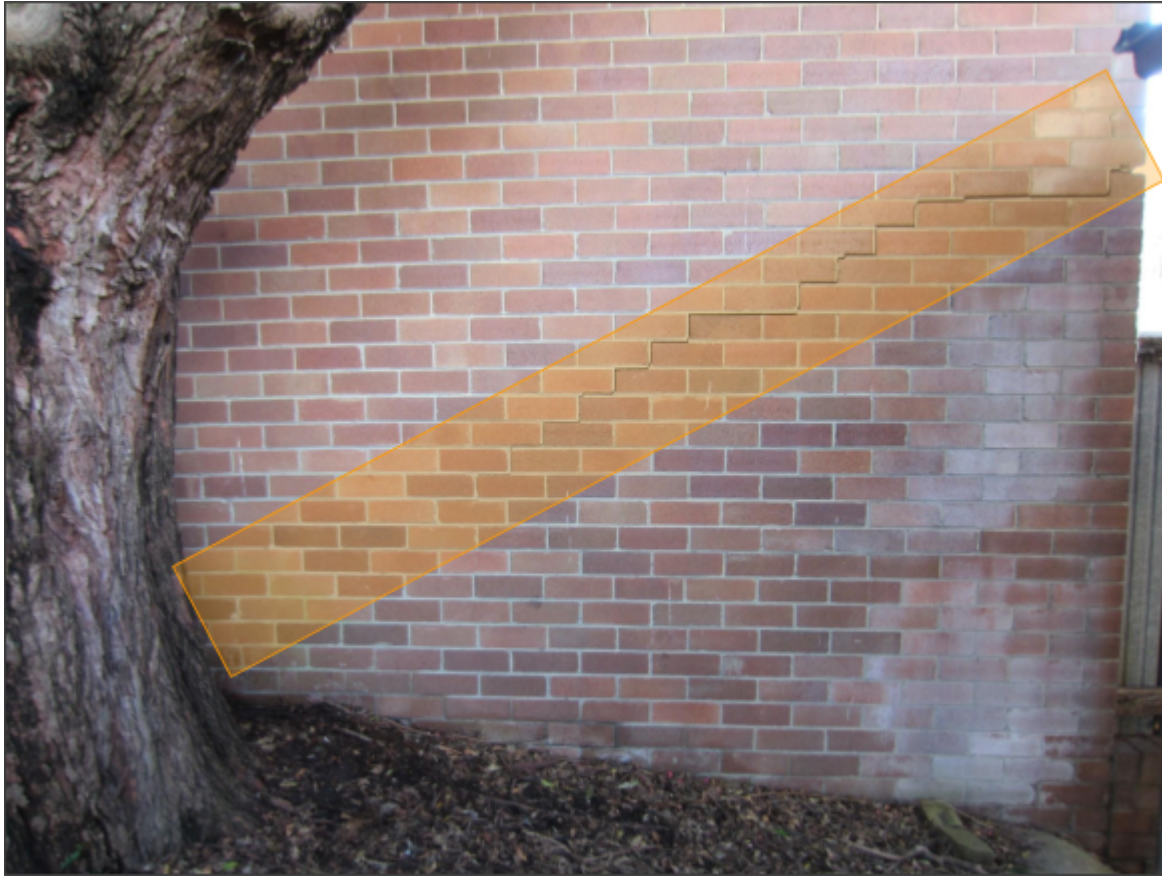
Photo D: Highlighting the extent of the crack in the wall. Tree viewed from south.

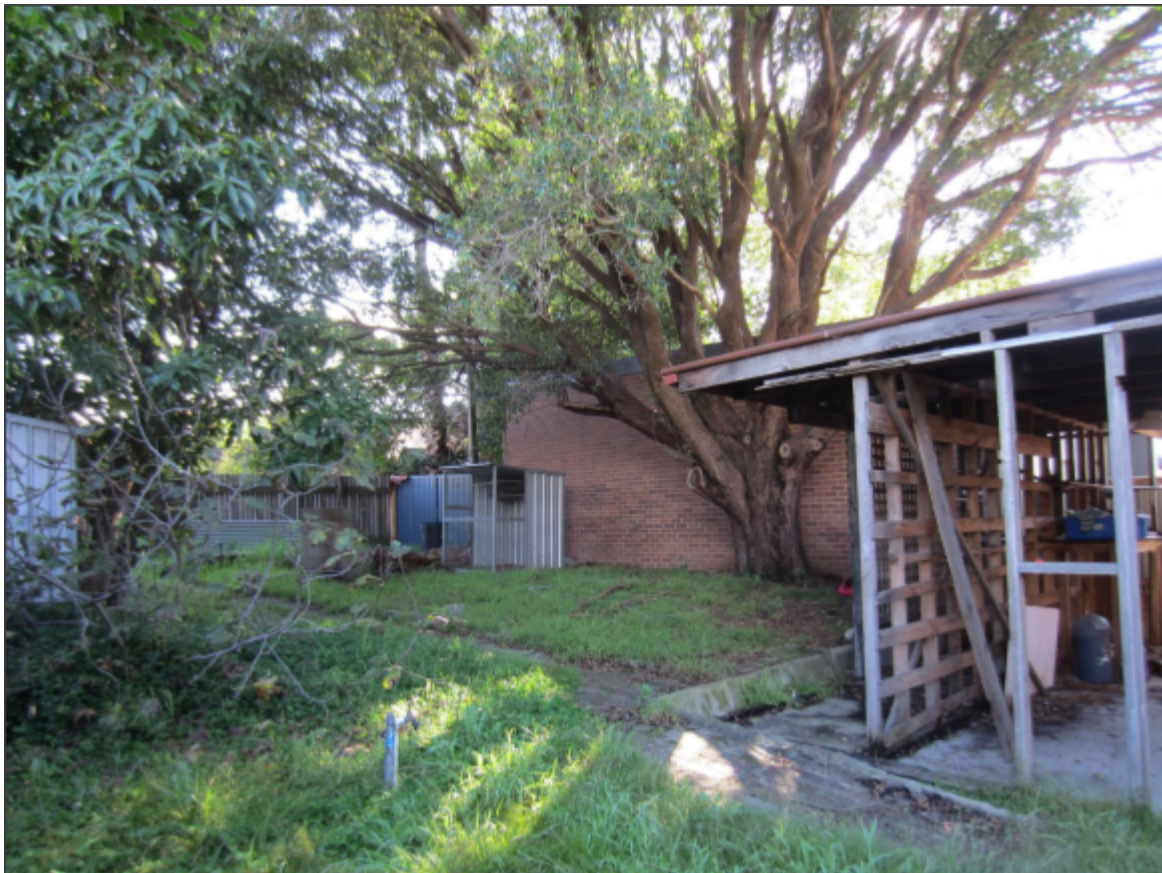
6. The tree is not considered suitable to be transplanted due to the structural defect.
7. Changes to the tree's growing context such as demolition of the neighbouring building and soil disturbance, would open the tree's crown to different wind loading, and affect the tree's health and condition.

8. The tree has been given a Short Useful Life Expectancy due to the structural defect and limited growing room with respect to the proximity of the neighbouring building. And although the tree has been assessed as High significance, the Short ULE results in a Low Retention Value, based on the IACA STARS method.

Photo E: Growing context of the tree. Tree viewed from southeast.
