HERITAGE ASSESSMENT

3 Wolseley Road, Drummoyne

September 2020 | J4421

**Weir
Phillips**
Heritage
and Planning

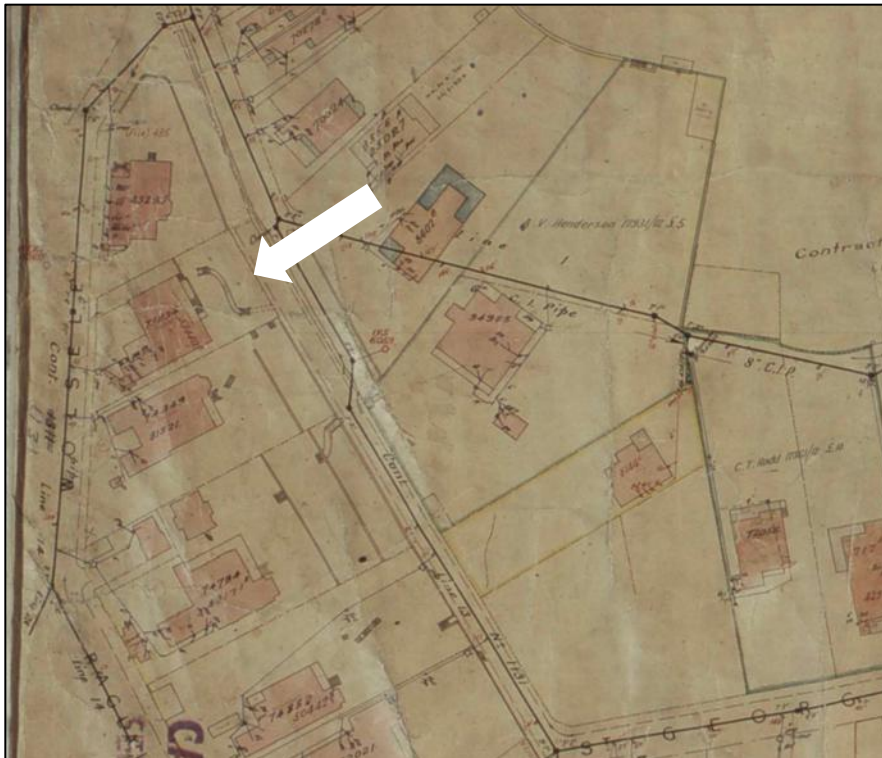
Figure 6: Sheet 23, Water Board Map of Drummoyne (1932).
Sydney Water

Figure 6, a Water Board Map of the area from 1932, shows the footprint and significant site features of dwellings. The map indicates the existence of a set of stairs from St Georges Crescent that led to what was likely a verandah and entry to the subject dwelling. Other features of note is that the Wolseley Street elevation appears to have had a verandah as well.

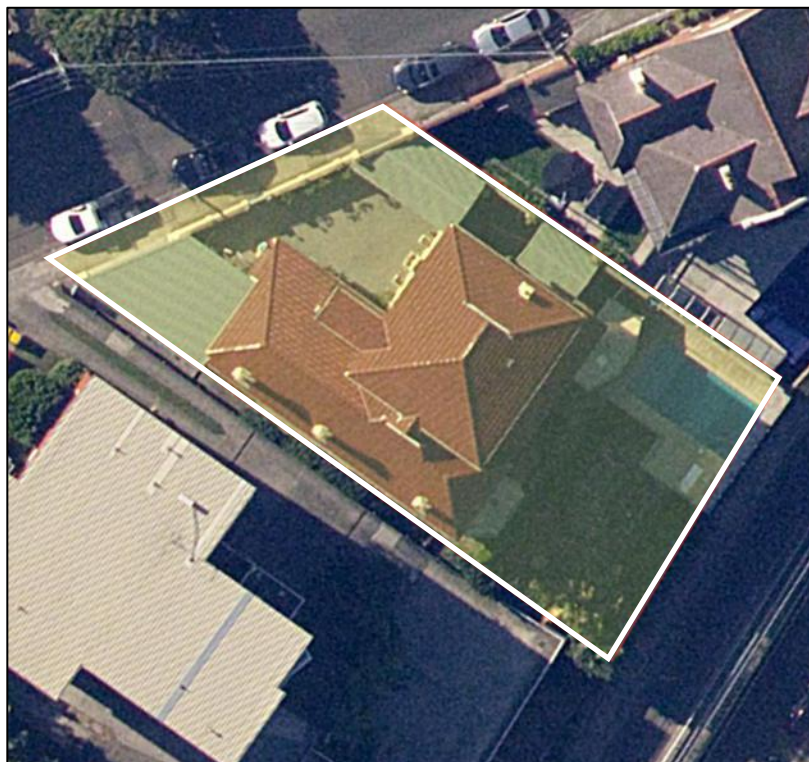
Figure 7: Aerial photograph of subject site.
SIX Maps, 2020

The subject site comprises an irregular shaped allotment with frontage to Wolseley Street and St Georges Crescent. The site is terraced into several levels on the east side by means of cutting into the rockface. The garden addressing St Georges Crescent has small plantings and a hedge along the southeastern side. There is a swimming pool raised above the garden to the northeast. A sandstone fence with piers and a timber gate borders the eastern side of the property. There is a garage constructed from sandstone with two openings on this side. A second garage constructed from rendered brick with a metal roof is attached to the northwest side of the dwelling, while there is a timber carport with metal roof on the northern side. The western side of the garden addressing Wolseley Street is paved with small plantings in pots. The total site area is approximately 720m².

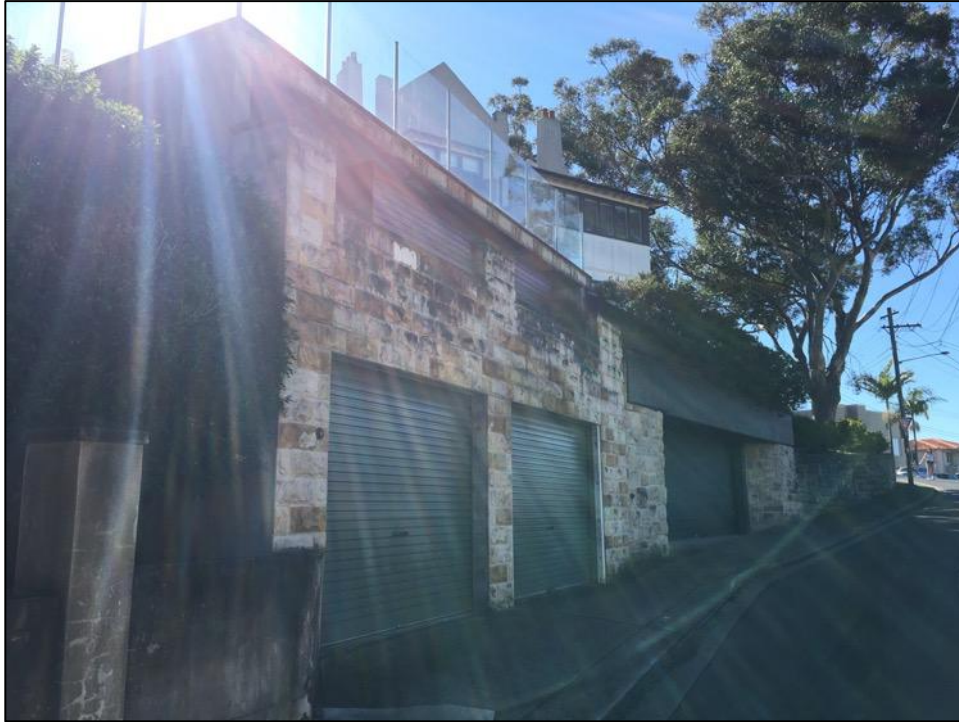
Figure 10: Rear garages.

- There is no original landscaping or vegetation.
- The boundary fences have been replaced with the existing.
- The front garage is not original.
- The rear garage is not original, however, the sandstone likely is.
- The garages at the rear and front of the site are not original.
- It is unclear whether the stairs visible in the 1940s aerial photograph are the same as exist now, notwithstanding, they appear to terminate further from the subject dwelling than they originally did. The historic entry from St Georges Crescent has been obscured by the existing garden arrangement.

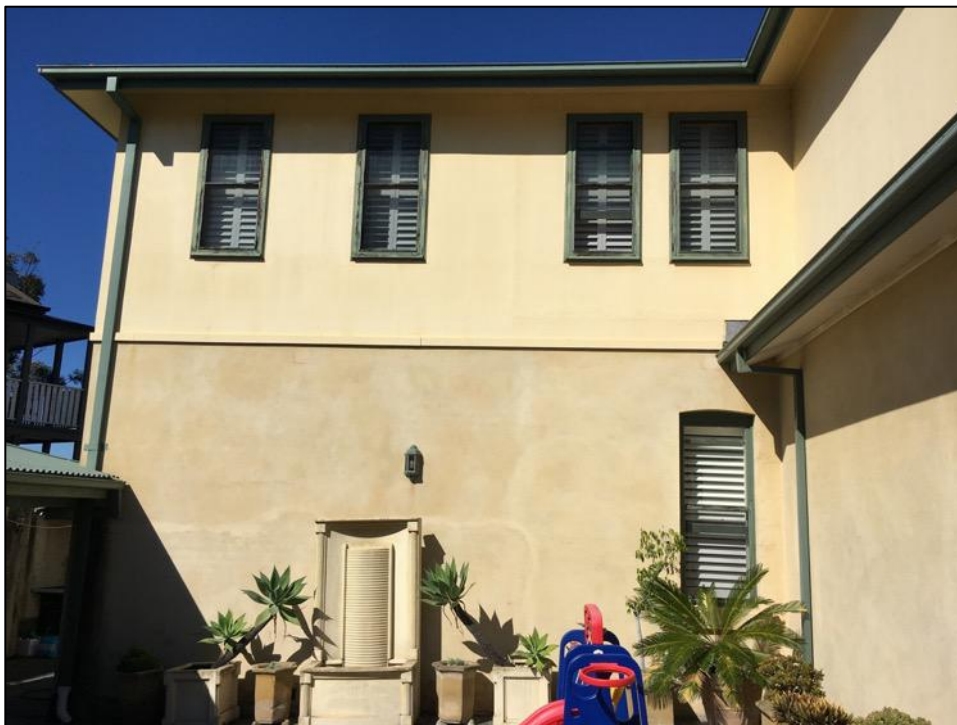
Figure 12: Front elevation of the principal building form.

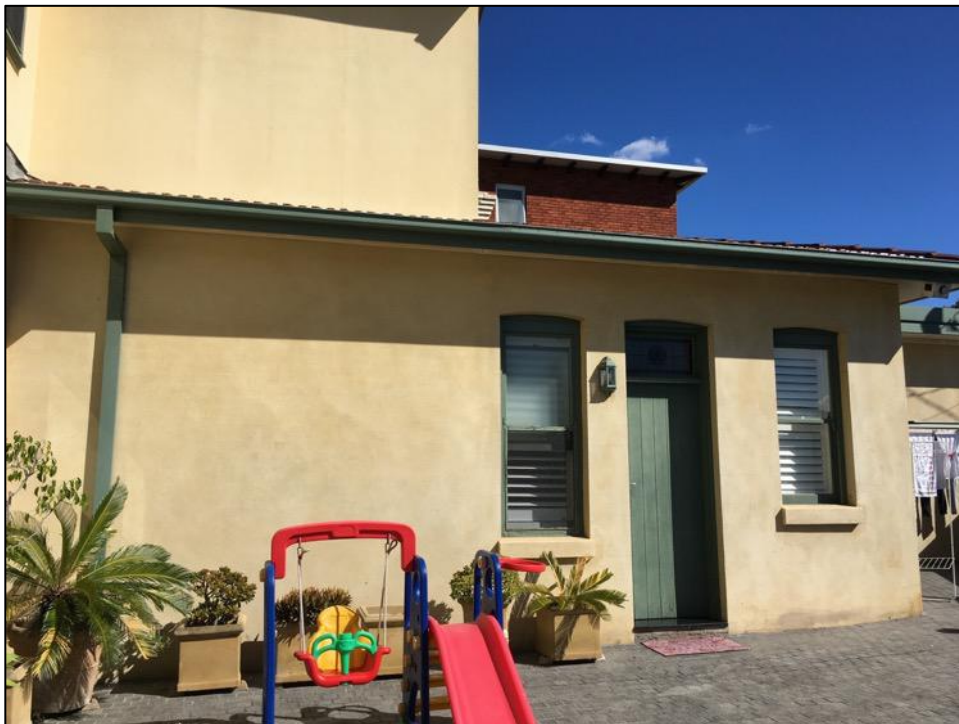
Figure 14: The main entry door.

- A dormer window has been added to the north-western elevation.
- The roof cladding has been replaced with the existing glazed terracotta tiles.
- The existing entry door and top light to the front elevation addressing Wolseley Street is a later addition.

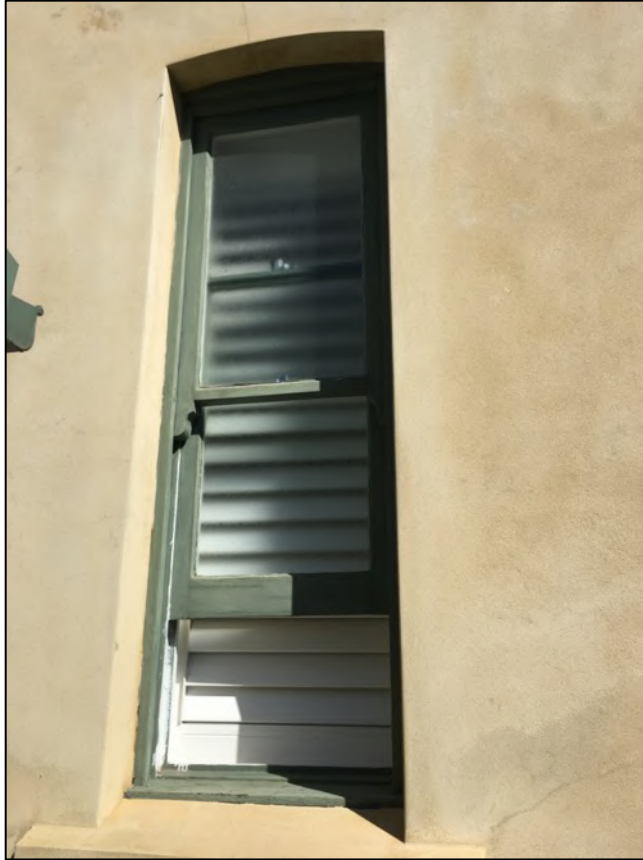
Figure 17: The only original window to the dwelling.

The northern and southern elevations are plain in detailing and have timber-framed window openings. There is one window on the northern elevation (Figure 17) which is original to the dwelling.

- All but one of the windows to the ground-floor northern elevation and two to the lower ground-floor rear elevation has been replaced.

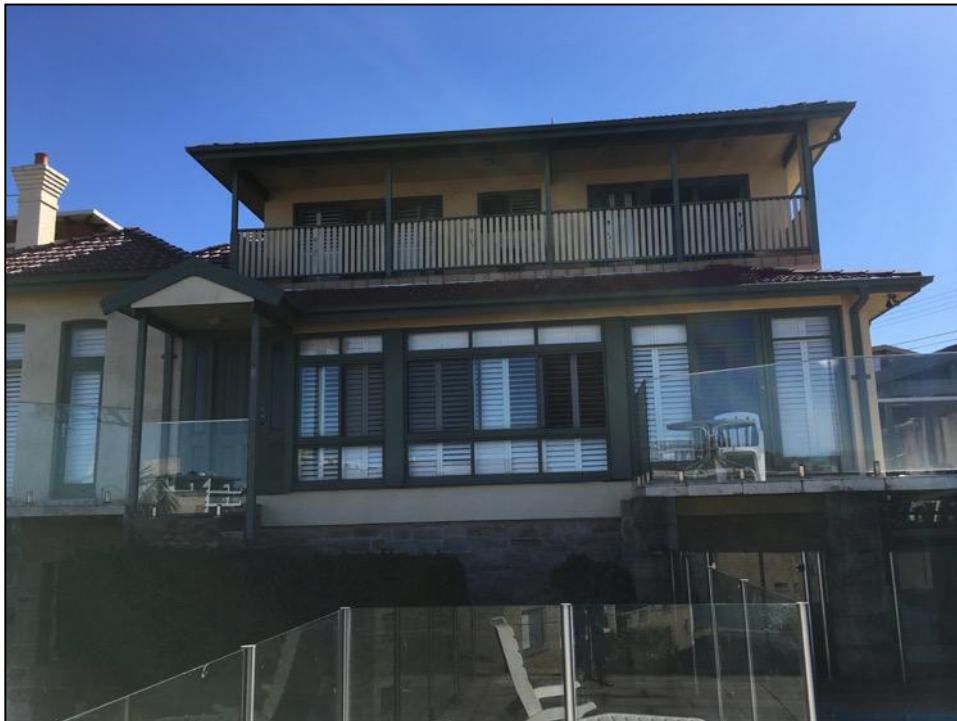
Figure 18: Rear elevation.

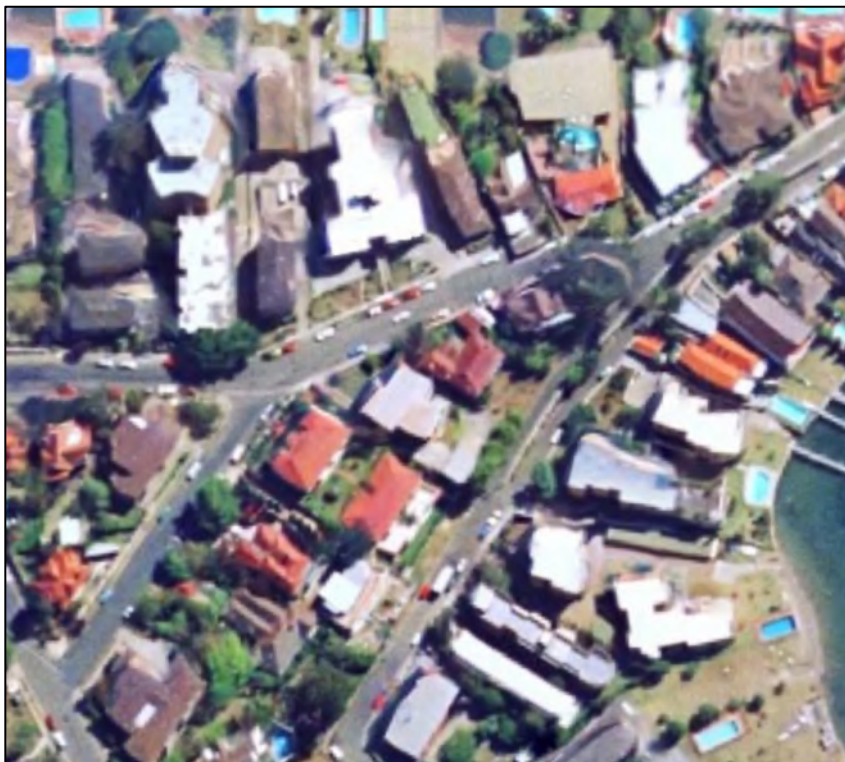
Figure 45: Aerial photograph of subject site (c. 1990s).

For the following, refer to Figure 44, an aerial photograph of the subject site from the 1940s and to Figure 45, an aerial photograph from the 1990s, prior to the alterations and additions.

No. 3 Wolseley Street demonstrates a low degree of integrity and has undergone significant alterations and additions over time. This is analysed in detail below. For a more comprehensive fabric survey of the interior, refer to Appendices 1 and 2 at the end of this report.

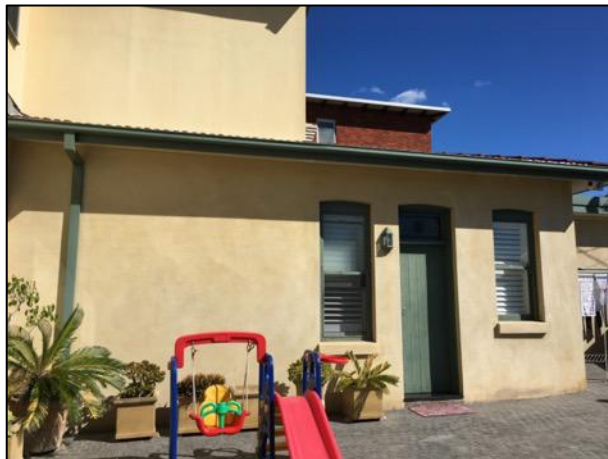
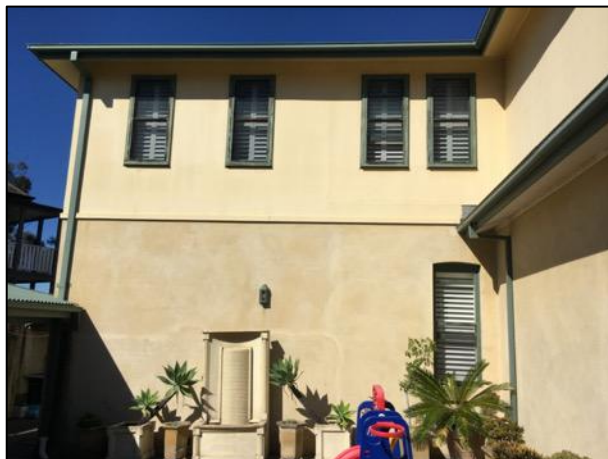
Building:	Elevation: Rear	
Address: 3 Wolseley Street		Date: August 2020

Element	Materials/ Comments	Integrity
Roof	Glazed terracotta tiles.	Not original. Inappropriate replacement.
Walls	Rendered and painted. Lower half is on sandstone base.	Walls not original, nor appropriate. Sandstone base is original, however, the columns supporting the projecting balconies are not.
Windows	Ground Floor: 6 x timber-framed glazed windows with top lights and bottom lights. First Floor: 1 x timber-framed window.	None are original.
Doors	Lower Ground Floor: 2 x timber-framed sash windows. Ground Floor: 2 x timber-framed doors with top lights. 1 x timber-framed door with side lights. 1 x timber-framed door with glazing. First Floor: 2 x timber-framed French doors.	Lower ground floor windows likely original. The others are not.
Other Features	Lower Ground Floor: 1 x sandstone stair to rear entry door. Ground Floor: 2 x balconies with glazed balustrade and sandstone floors. First Floor: 1 x verandah with timber balustrade and tiled floor.	None are original.

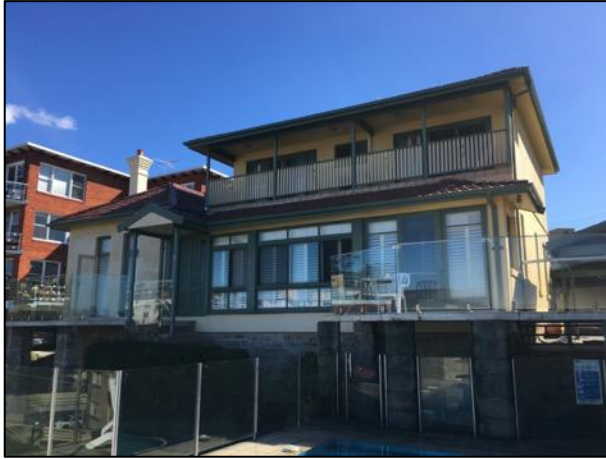
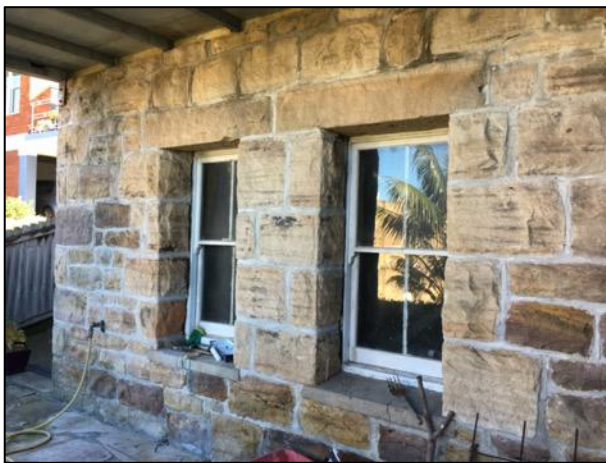
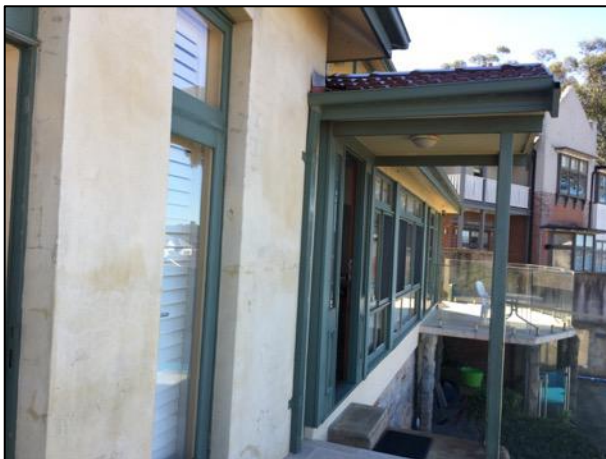
Building:	Elevation: Northern	
Address: 3 Wolseley Street		Date: August 2020

Element	Materials/ Comments	Integrity
Roof	Glazed terracotta tiles.	Not original. Inappropriate replacement.
Walls	Rendered and painted. Shallow sandstone base.	Walls not original, nor appropriate. Sandstone base is original.
Windows	Ground Floor: 3 x timber-framed sash windows.	Only one is original (as noted elsewhere). The others are replacements.
Doors		
Other Features

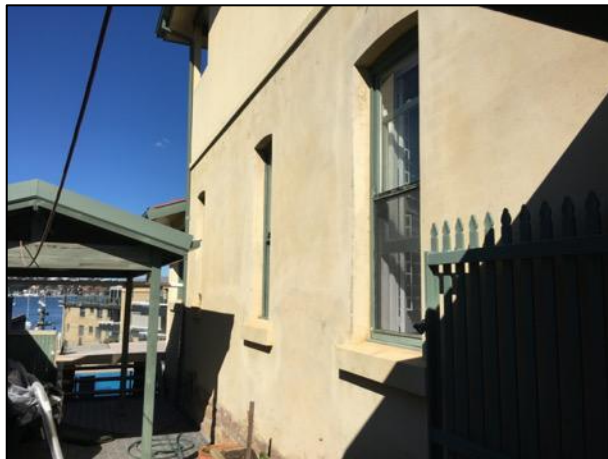
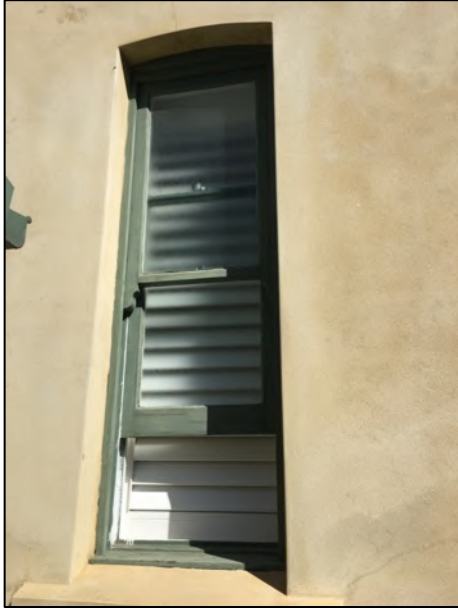
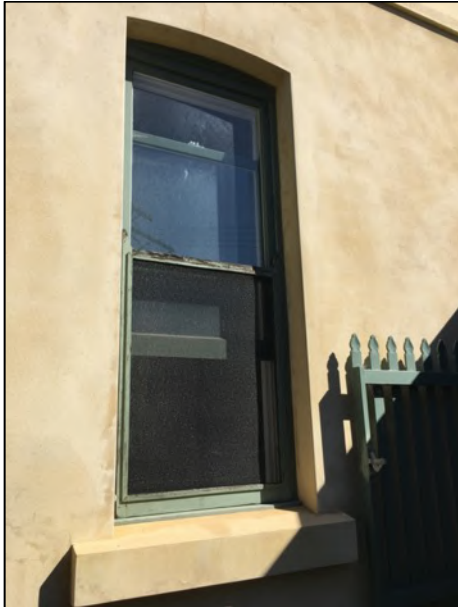
Building:	Elevation: Southern	
Address: 3 Wolseley Street		Date: August 2020

Element	Materials/ Comments	Integrity
Roof	Glazed terracotta tiles.	Not original. Inappropriate replacement.
Walls	Rendered and painted. Shallow sandstone base.	Walls not original, nor appropriate. Sandstone base is original.
Windows	Ground Floor: 3 x timber-framed sash windows.	None are original.
Doors		
Other Features

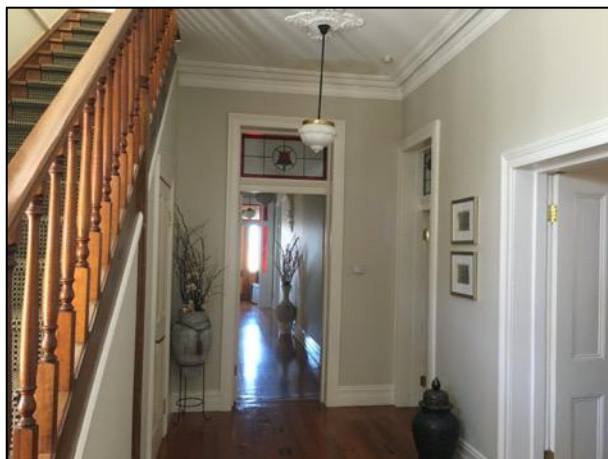
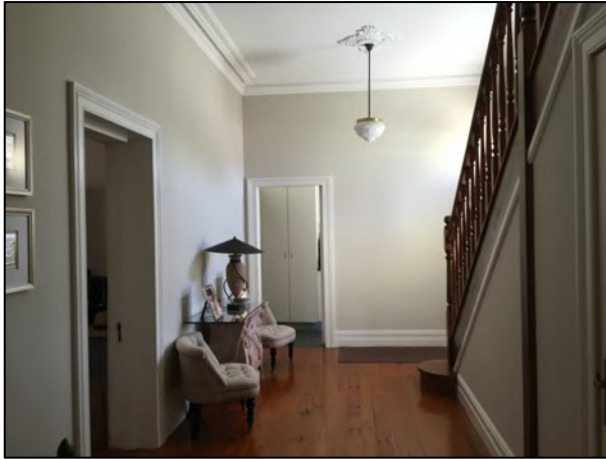
Element	Materials/ Comments	Integrity
Floor	Timber floor.	Original or appropriate replacement.
Skirting	Timber; simple moulded profile; painted.	Not original.
Walls	Rendered and painted.	Original.
Doors	Timber panelled with timber profiled architraves; painted.	Doors are original or appropriate replacement.
Cornice	Detailed	Not original.
Ceiling	Plain plaster with rose.	Not original.
Stairs	Timber with timber balustrade.	Not original.
Fireplace	None.	
Other Features	Leadlight top lights.	Not original.

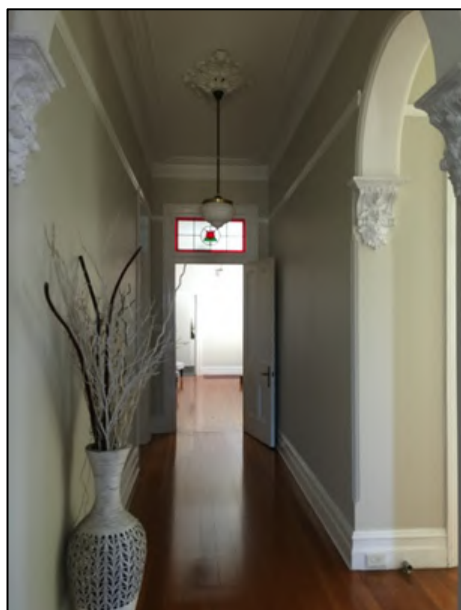
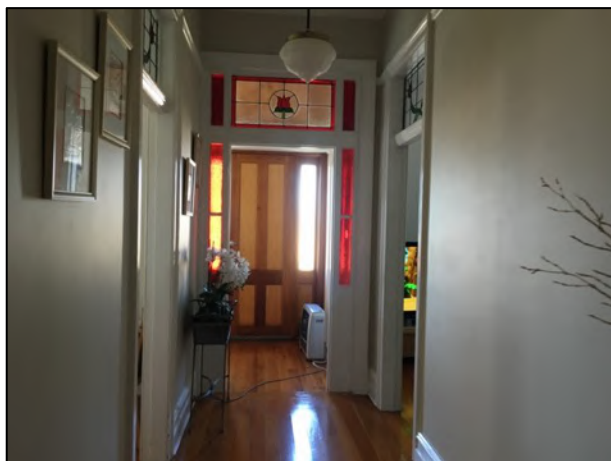
Building:	Room: Main Hallway	
Address: 3 Wolseley Street		Date: August 2020

Element	Materials/ Comments	Integrity
Floor	Timber floor.	Original or appropriate replacement.
Skirting	Timber; simple moulded profile; painted.	Not original.
Walls	Rendered and painted with elaborate moulded plasterwork.	Walls are original. Plasterwork is a later addition.
Doors	Timber panelled with timber profiled architraves; painted.	Doors are original or appropriate replacement.
Cornice	Detailed	Not original.
Ceiling	Plain plaster with rose.	Not original.
Fireplace	None.	
Other Features	Leadlight top lights.	Not original.

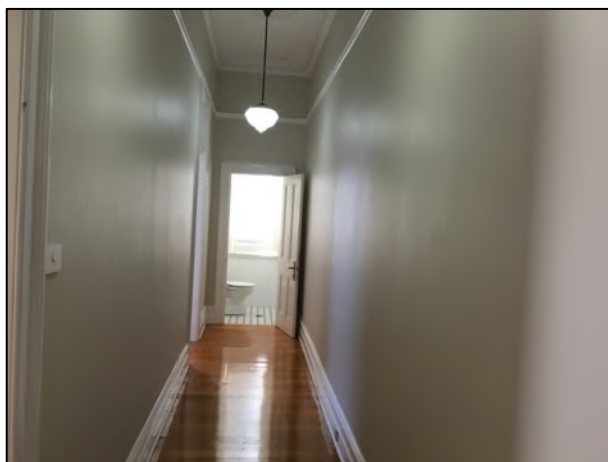
Building:	Room: North-east Hallway	
Address: 3 Wolseley Street		Date: August 2020

Element	Materials/ Comments	Integrity
Floor	Timber floor.	Original or appropriate replacement.
Skirting	Timber; simple moulded profile; painted.	Original or appropriate replacement.
Walls	Rendered and painted.	Original.
Doors	Timber panelled with timber profiled architraves; painted.	Doors are original or appropriate replacement.
Cornice	Detailed	Not original.
Ceiling	Plain plaster with rose.	Not original.
Fireplace	None.	
Other Features	Leadlight top lights. Picture rails: timber; simple moulded profile; painted.	Top lights not original. Picture rails original or appropriate replacement.

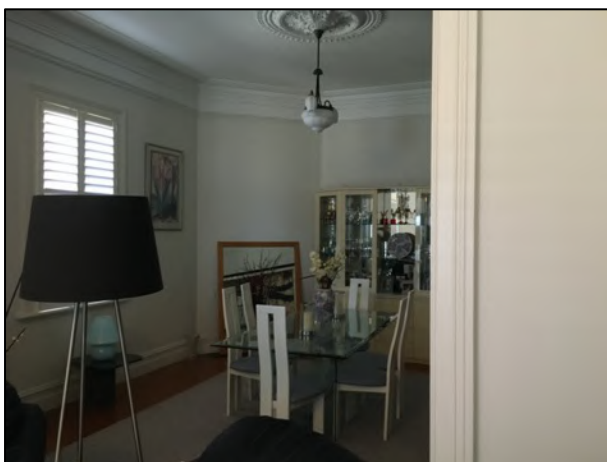
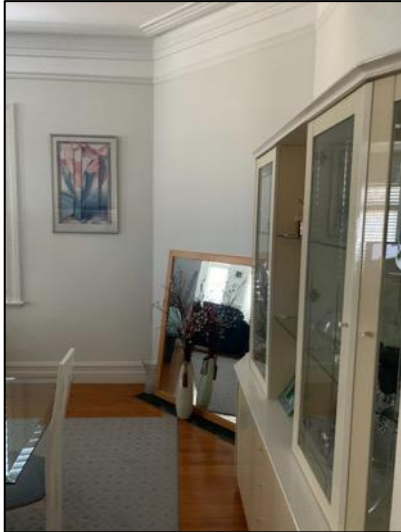
Building:	Room: Dining Room	
Address: 3 Wolseley Street		Date: August 2020

Element	Materials/ Comments	Integrity
Floor	Timber floor.	Original or appropriate replacement.
Skirting	Timber; simple moulded profile; painted.	Not original.
Walls	Rendered and painted.	Original.
Doors	Timber panelled with timber profiled architraves; painted.	Doors are original or appropriate replacement.
Cornice	Detailed	Not original.
Ceiling	Plain plaster with rose.	Not original.
Fireplace	None.	
Other Features	None.

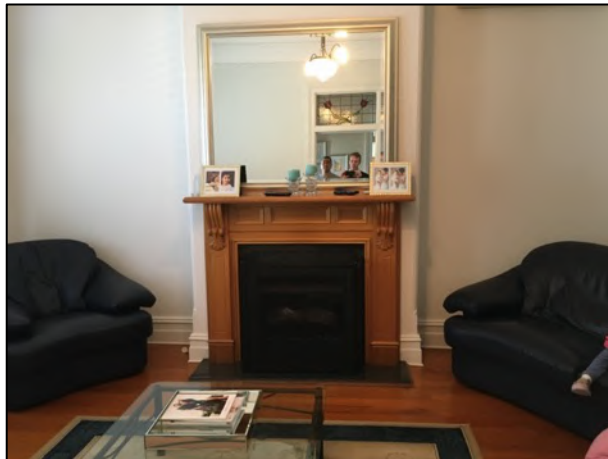
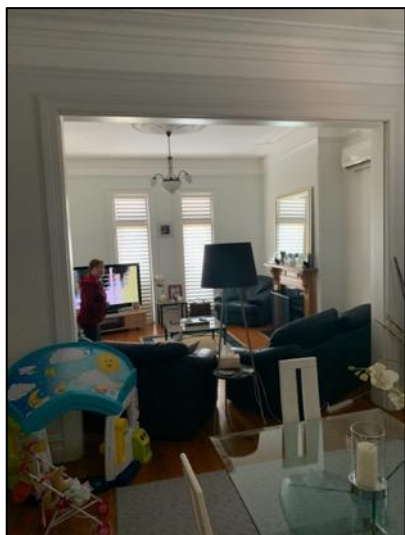
Building:	Room: Living Room	
Address: 3 Wolseley Street		Date: August 2020

Element	Materials/ Comments	Integrity
Floor	Timber floor.	Original or appropriate replacement.
Skirting	Timber; simple moulded profile; painted.	Not original.
Walls	Rendered and painted.	Original.
Doors	Timber panelled with timber profiled architraves; painted.	Doors are original or appropriate replacement.
Cornice	Detailed	Not original.
Ceiling	Plain plaster with rose.	Not original.
Fireplace	Cast iron fireplace with timber mantelpiece and tiled floor.	Not original.
Other Features	None.

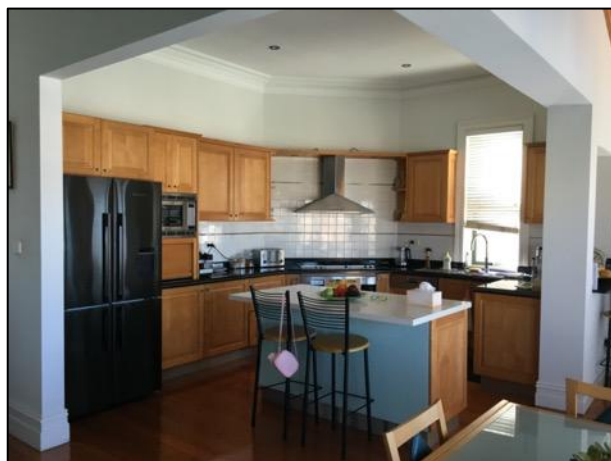
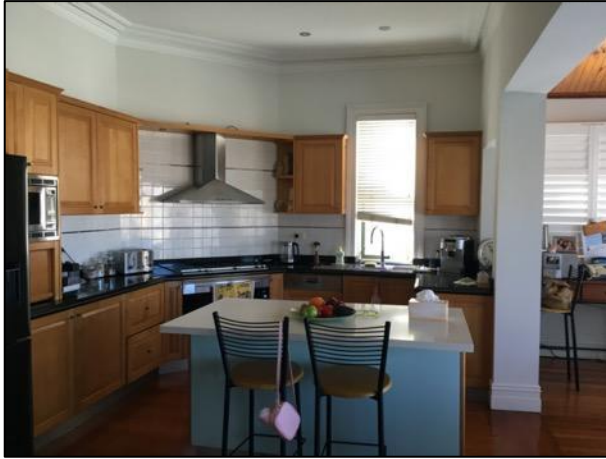
Building:	Room: Kitchen	
Address: 3 Wolseley Street		Date: August 2020

Element	Materials/ Comments	Integrity
Floor	Timber floor.	Not original.
Skirting	Timber; simple moulded profile; painted.	Not original.
Walls	Rendered and painted with tiles.	Original with later openings.
Doors	Timber panelled with timber profiled architraves; painted.	Doors are original or appropriate replacement.
Cornice	Simple.	Not original.
Ceiling	Plain plaster.	Not original.
Fireplace	None.	
Other Features	Modern fit-out with timber cabinetry.	Not original.

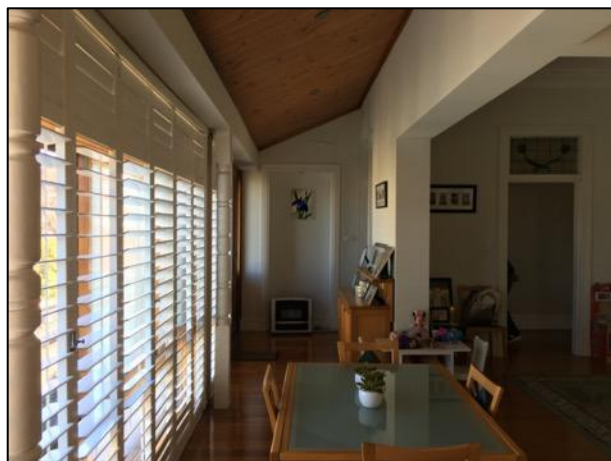
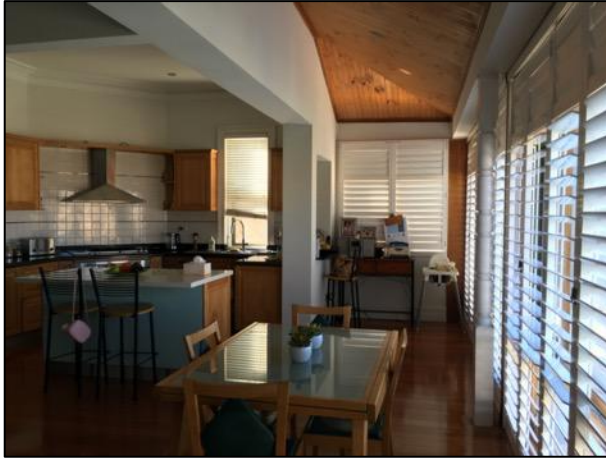
Building:	Room: Sun Room	
Address: 3 Wolseley Street		Date: August 2020

Element	Materials/ Comments	Integrity
Floor	Timber floor.	Original or appropriate replacement.
Skirting	Timber; simple moulded profile; painted.	Not original.
Walls	Rendered and painted with tiles.	Original with later openings.
Doors	Timber with profiled architrave and glazed openings.	Not original.
Cornice	None.	
Ceiling	Timber	Not original.
Fireplace	None.	
Other Features	Timber columns.	Not original.

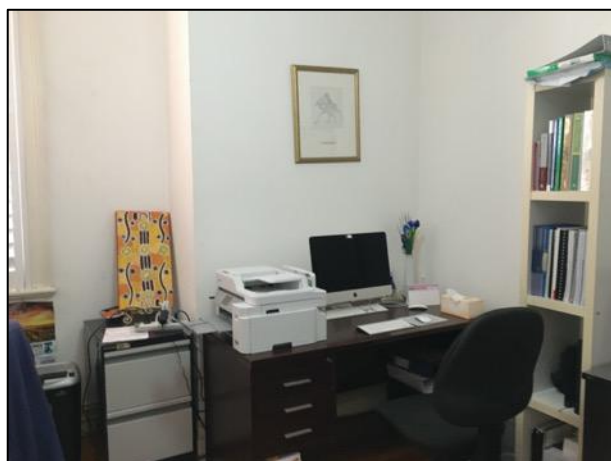
Building:	Room: Study	
Address: 3 Wolseley Street		Date: August 2020

Element	Materials/ Comments	Integrity
Floor	Timber.	Original or appropriate replacement.
Skirting	Timber; simple moulded profile; painted.	Not original.
Walls	Rendered and painted.	Original.
Doors	Timber panelled with timber profiled architraves; painted.	Doors are original or appropriate replacement.
Cornice	Simple.	Not original.
Ceiling	Plain plaster with rose.	Not original.
Fireplace	None.	
Other Features	None.

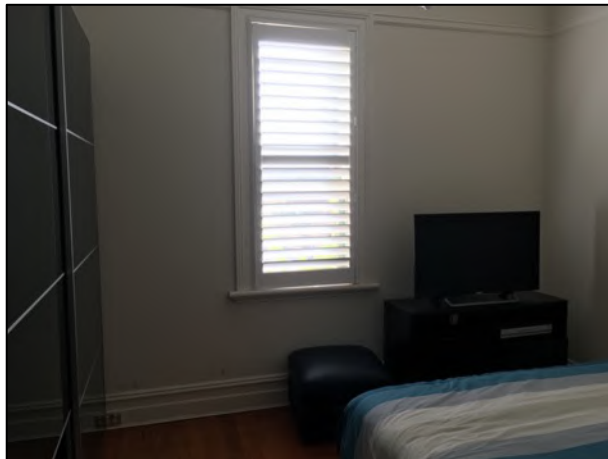
Building:	Room: Bedroom 1	
Address: 3 Wolseley Street		Date: August 2020

Element	Materials/ Comments	Integrity
Floor	Timber.	Original or appropriate replacement.
Skirting	Timber; simple moulded profile; painted.	May be original.
Walls	Rendered and painted.	Original.
Doors	Timber panelled with timber profiled architraves; painted.	Doors are original or appropriate replacement.
Cornice	Simple.	Not original.
Ceiling	Plain plaster with rose.	Not original.
Fireplace	None.	
Other Features	Picture rail: timber; simple moulded profile; painted.	Original or appropriate replacement.

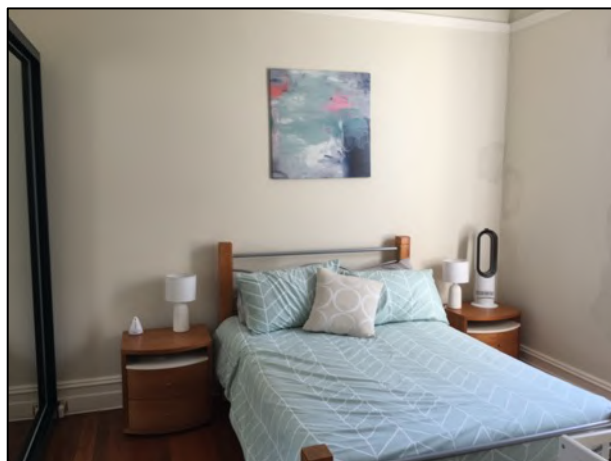
Building:	Room: Bedroom 2	
Address: 3 Wolseley Street		Date: August 2020

Element	Materials/ Comments	Integrity
Floor	Timber.	Original or appropriate replacement.
Skirting	Timber; simple moulded profile; painted.	May be original.
Walls	Rendered and painted.	Original.
Doors	Timber panelled with timber profiled architraves; painted.	Doors are original or appropriate replacement.
Cornice	Simple.	Not original.
Ceiling	Plain plaster with rose.	Not original.
Other Features	Picture rail: timber; simple moulded profile; painted.	Original or appropriate replacement.

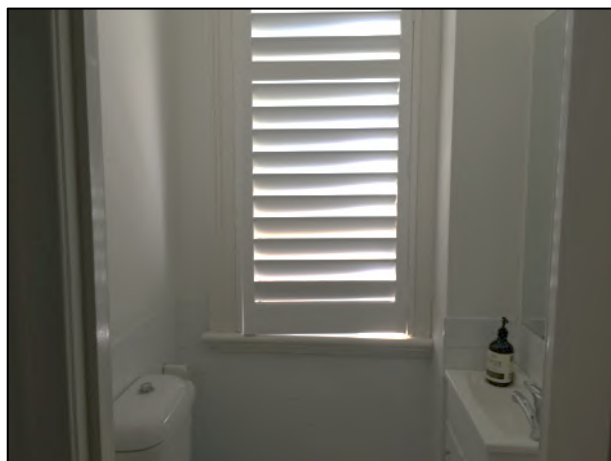
Building:	Room: WC	
Address: 3 Wolseley Street		Date: August 2020

Element	Materials/ Comments	Integrity
Floor	Tiled.	Not original.
Skirting	None.	
Walls	Tiled then rendered and painted.	Original with later tiling.
Doors	Timber panelled with timber profiled architraves; painted.	Doors are original or appropriate replacement.
Cornice	Simple.	May be original.
Ceiling	Plain plaster.	May be original.
Fireplace	None.	
Other Features	Modern fit-out with toilet.	Not original.

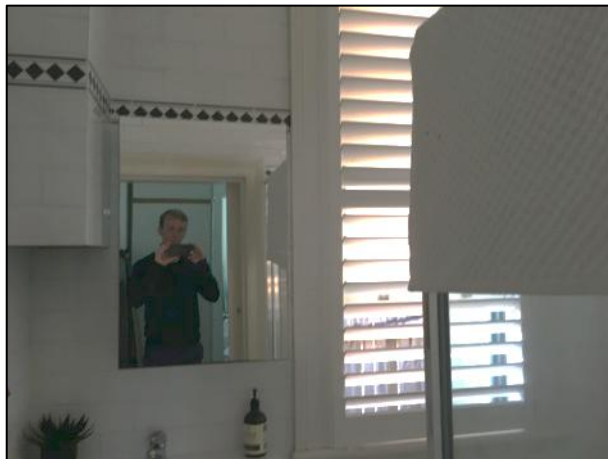
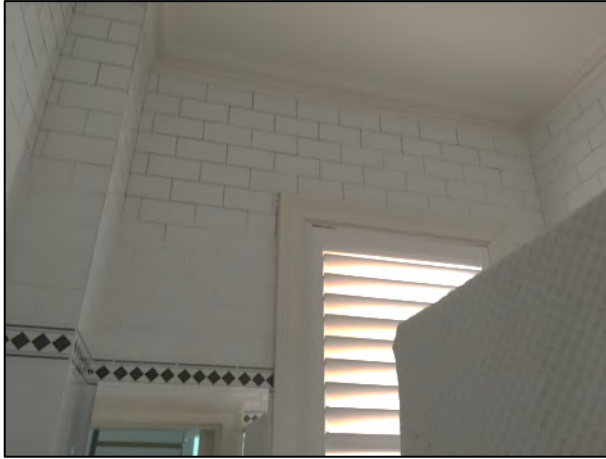
Building:	Room: Bathroom 1	
Address: 3 Wolseley Street		Date: August 2020

Element	Materials/ Comments	Integrity
Floor	Tiled.	Not original.
Skirting	None.	
Walls	Tiled.	Original with later tiling.
Doors	Timber panelled with timber profiled architraves; painted.	Doors are original or appropriate replacement.
Cornice	Simple.	May be original.
Ceiling	Plain plaster.	May be original.
Fireplace	None.	
Other Features	Modern fit-out with timber cabinetry and shower.	Not original.

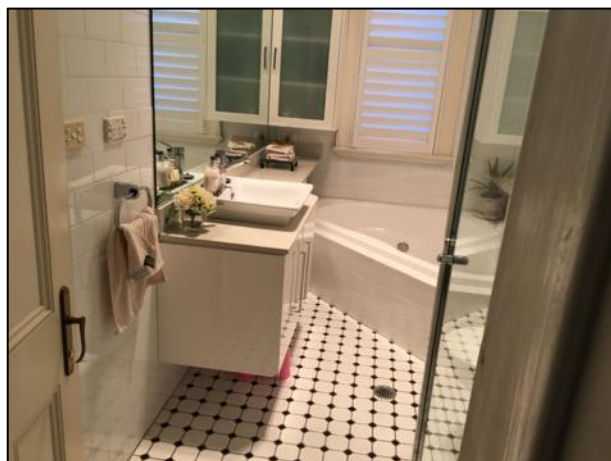
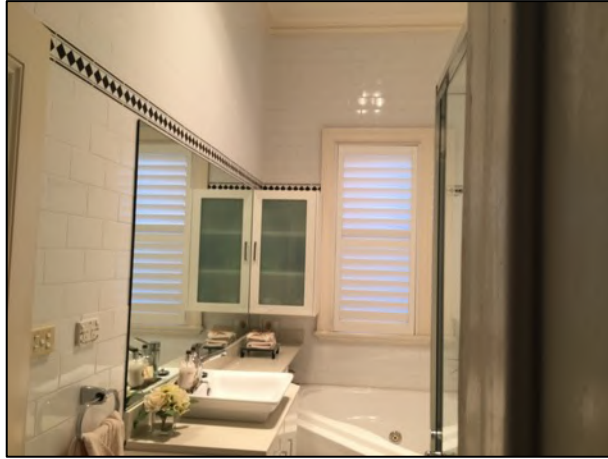
Building:	Room: Bathroom 2	
Address: 3 Wolseley Street		Date: August 2020

Element	Materials/ Comments	Integrity
Floor	Tiled.	Not original.
Skirting	None.	
Walls	Tiled, then rendered and painted.	Original with later tiling.
Doors	Timber panelled with timber profiled architraves; painted.	Doors are original or appropriate replacement.
Cornice	Simple.	May be original.
Ceiling	Plain plaster.	May be original.
Fireplace	None.	
Other Features	Modern fit-out with timber cabinetry and shower and bath.	Not original.

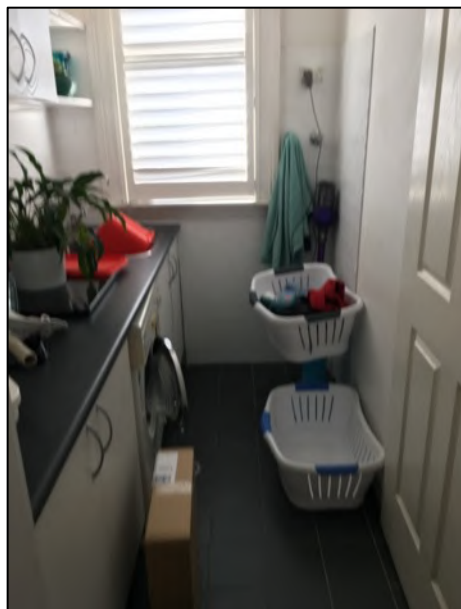
Building:	Room: Laundry	
Address: 3 Wolseley Street		Date: August 2020

Element	Materials/ Comments	Integrity
Floor	Tiled.	Not original.
Skirting	None.	
Walls	Rendered and painted.	Not original.
Doors	Timber panelled with timber profiled architraves; painted.	Doors are original or appropriate replacement.
Cornice	Simple.	May be original.
Ceiling	Plain plaster.	May be original.
Fireplace	None.	
Other Features	Modern fit-out with timber cabinetry.	Not original.

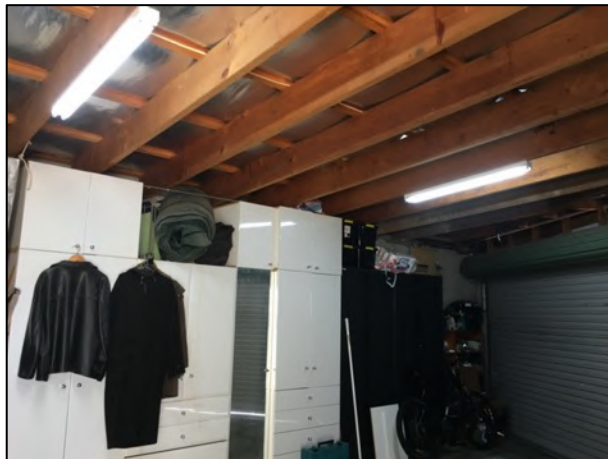
Element	Materials/ Comments	Integrity
Floor	Concrete.	Not original.
Skirting	None.	
Walls	Concrete.	Not original.
Doors	Metal roller door.	Not original.
Cornice	None.	Not original.
Ceiling	Timber rafters.	Not original.
Fireplace	None.	
Other Features	None.

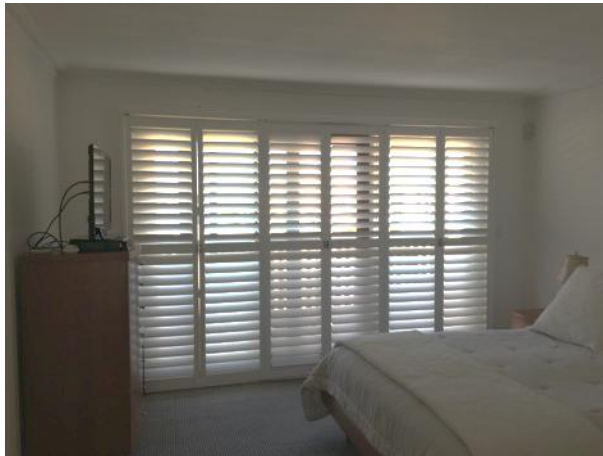
Building:	Room: Bedroom 1	
Address: 3 Wolseley Street		Date: August 2020

Element	Materials/ Comments	Integrity
Floor	Carpet, likely timber below.	Not original.
Skirting	Timber; simple moulded profile; painted.	Not original.
Walls	Rendered and painted.	Not original.
Doors	Timber panelled with timber profiled architraves; painted.	Not original.
Cornice	Simple.	Not original.
Ceiling	Plain plaster with metal vent.	Not original.
Fireplace	None.	
Other Features	None.

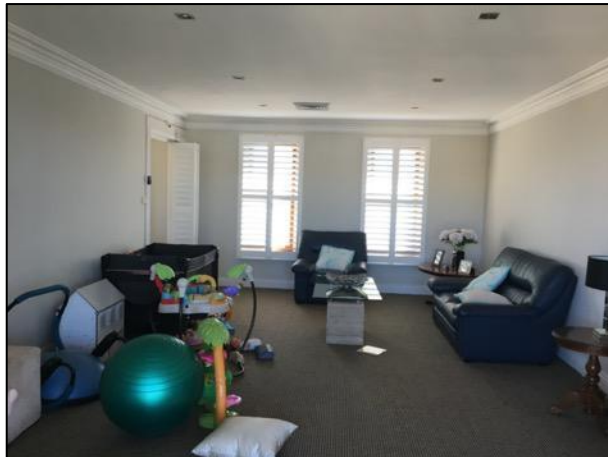
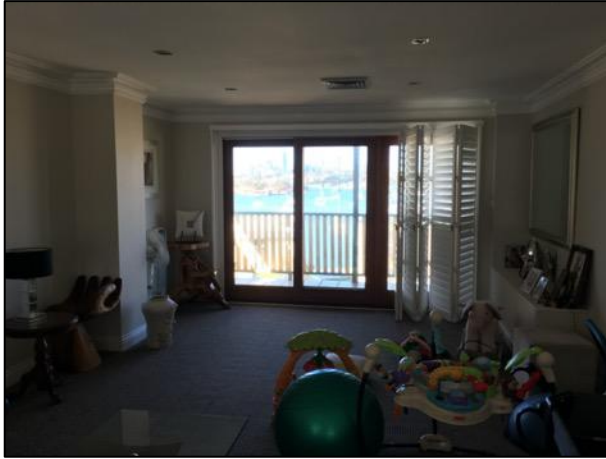
Building:	Room: Family Room	
Address: 3 Wolseley Street		Date: August 2020

Element	Materials/ Comments	Integrity
Floor	Carpet, likely timber below.	Not original.
Skirting	Timber; simple moulded profile; painted.	Not original.
Walls	Rendered and painted.	Not original.
Doors	Timber panelled with timber profiled architraves; painted.	Not original.
Cornice	Simple.	Not original.
Ceiling	Plain plaster with metal vent.	Not original.
Fireplace	None.	
Other Features	None.

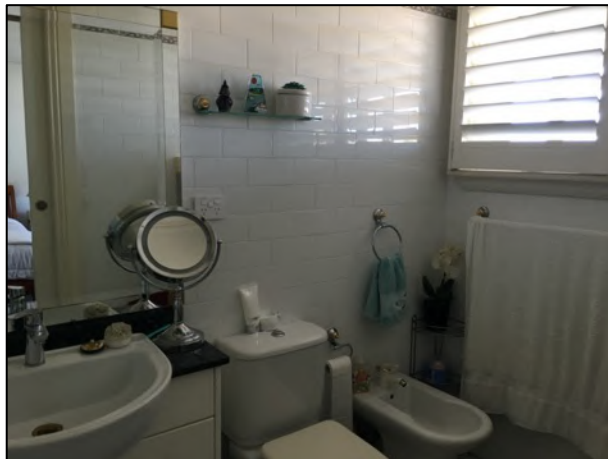
Building:	Room: Bathroom 1	
Address: 3 Wolseley Street		Date: August 2020

Element	Materials/ Comments	Integrity
Floor	Tiled.	Not original.
Skirting	None.	Not original.
Walls	Tiled.	Not original.
Doors	Timber panelled with timber profiled architraves; painted.	Not original.
Cornice	Simple.	Not original.
Ceiling	Plain plaster.	Not original.
Fireplace	None.	
Other Features	Modern fit-out with timber cabinetry and shower.	Not original.
